## U.S. Fish and Wildlife Service

### Manistee River/Sharon Road Habitat Restoration

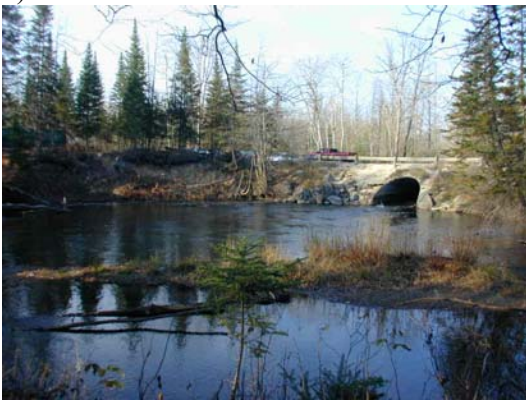
**Figure 2. Sharon Road, before construction**

The culvert was not large enough to pass water during precipitation events. Water collected on the upstream side of the culvert, warmed the water, and eroded the riverbanks. Due to lack of proper ditches and sediment basins, storm water ran down the road and directly into the river carrying with it sediments and other forms of habitat-

Brook trout and rainbow trout on the north branch of the Manistee River now have upstream access to an additional 12 river-miles of habitat, much of it high quality spawning habitat. Located in Kalkaska County, Michigan (figure 1), the Sharon Road/Manistee River road/stream crossing project began construction on November 9, 2001. A single culvert was removed and replaced with a timber bridge (figures 2 and 3).

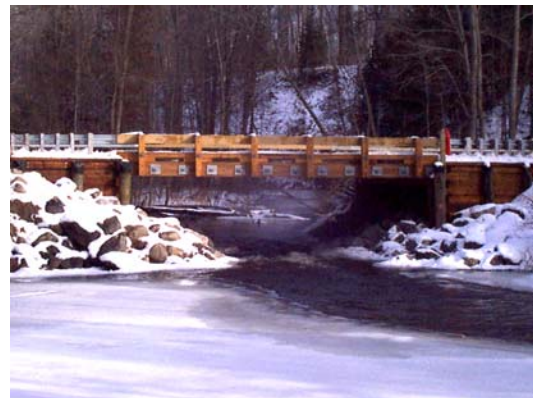
altering contamination. Construction of the timber bridge and hardening of the road surface (blacktop) alleviated water quality issues at the crossing. The timber bridge has enough clearance to accommodate a 50-year flood event.

**Figure 3. Sharon Road, after construction**
